# TEST REPORT

## DC18217-01-1

**REPORT ON TENSILE TESTING OF CLICKBRICK PRODUCTS BEFORE AND AFTER EM4 THERMAL AGING.**

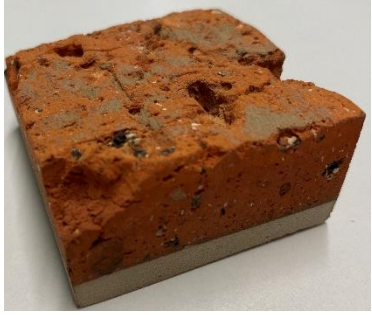
BRANZ sample number	Sample description	Sample image
24/106	Precut with a nominal size of 50 mm x 50 mm. The sample consisted of a red brick face bond to a light grey substrate

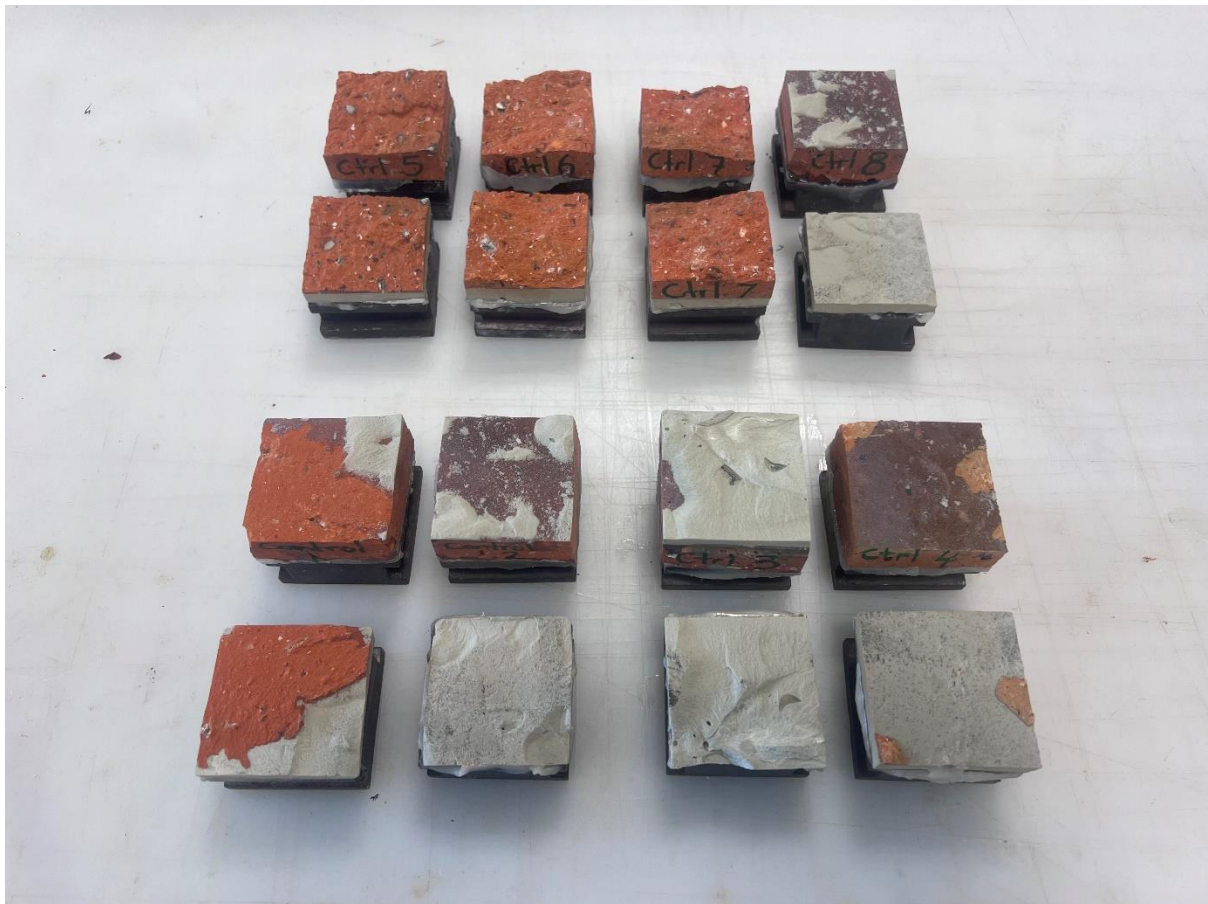
Figure 2. Images of the tested control samples showing the failure mode. Samples 1-4 bottom row (left to right), samples 5-8 top row (left to right)

The test results are given in Tables 2 and 3 and images of the failure mechanism are given in Figures 2 and 3.

Sample No.	Peak force (N)	Width <sup>1</sup> (mm)	Length <sup>1</sup> (mm)	Strength (MPa)	Failure Mode
1	3778	50.4	52.7	1.42	Mixed cohesive failure of the brick and substrate
2	4359	51.4	50.3	1.69	Adhesive failure
3	4980	51.8	54.4	1.77	Cohesive failure of the substrate
4	2568	51.4	50.3	0.99	Adhesive failure
5	4784	50.4	52.7	1.80	Cohesive failure of the brick
6	2913	50.4	52.7	1.10	Cohesive failure of the brick
7	4553	50.4	52.7	1.72	Cohesive failure of the brick
8	6364	51.4	50.3	2.46	Adhesive failure
<b>Average</b>	<b>4287</b>	<b>50.9</b>	<b>52.0</b>	<b>1.62</b>

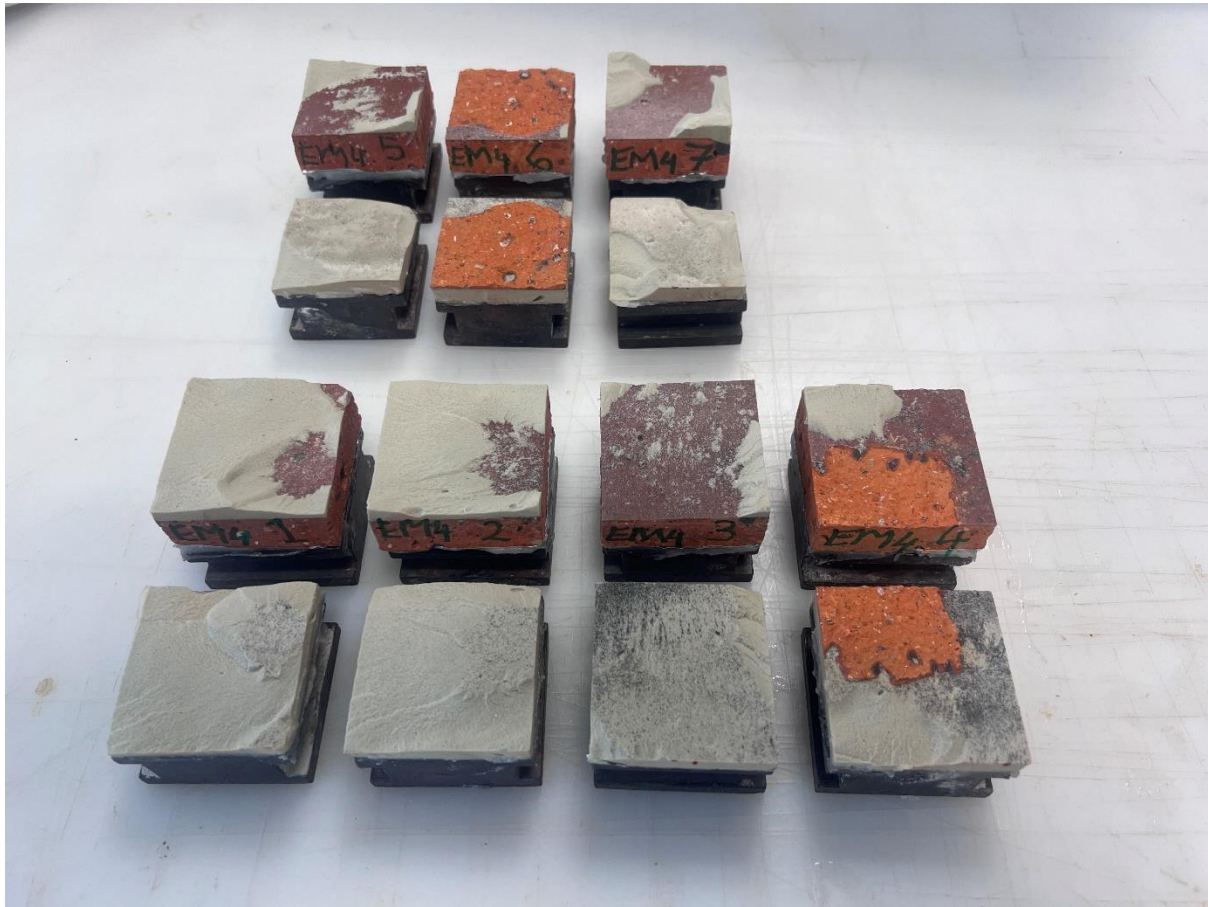
Figure 2. Images of the tested aged samples showing the failure mode. Samples 1-4 bottom row (left to right), samples 5-7 top row (left to right)

Sample No.	Peak force (N)	Width <sup>1</sup> (mm)	Length <sup>1</sup> (mm)	Strength (MPa)	Failure Mode
1	4111	50.9	51.8	1.56	Cohesive failure of the substrate
2	4282	50.9	51.7	1.63	Cohesive failure of the substrate
3	4498	50.9	52.5	1.68	Adhesive failure
4	2558	52.0	50.8	0.97	Mixed cohesive of the brick and adhesive failure
5	3950	51.0	51.3	1.51	Mixed cohesive of the substrate and adhesive failure
6	2698	52.3	51.3	1.01	Cohesive failure of the brick
7	2629	52.1	52.0	0.97	Mixed cohesive of the substrate and adhesive failure
<b>Average</b>	<b>3532</b>	<b>51.4</b>	<b>51.6</b>	<b>1.33</b>
