CLICKBRICK NZ – VM1

Shelby Wright Test Report

SWTL Reference:
J0089

Clickbrick Limited requested testing to NZBC E2/VM1

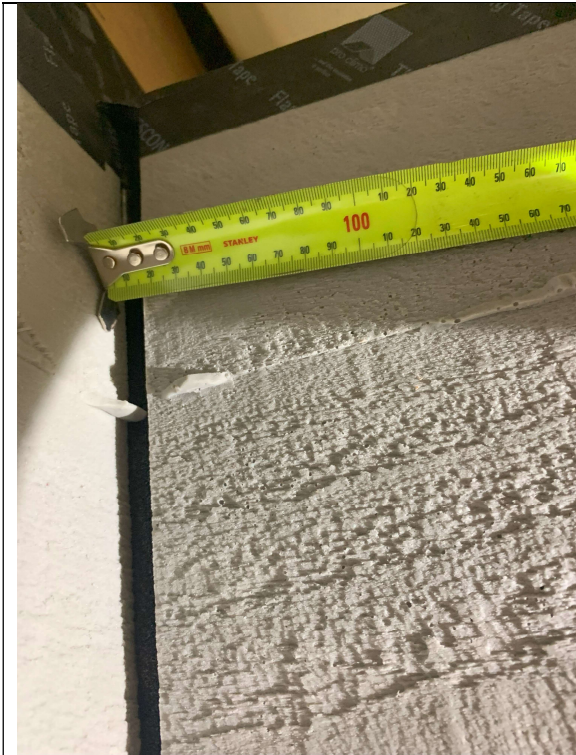
*Figure 3 Exterior –
Approx 15mm gap
between panels at
internal corner junction*

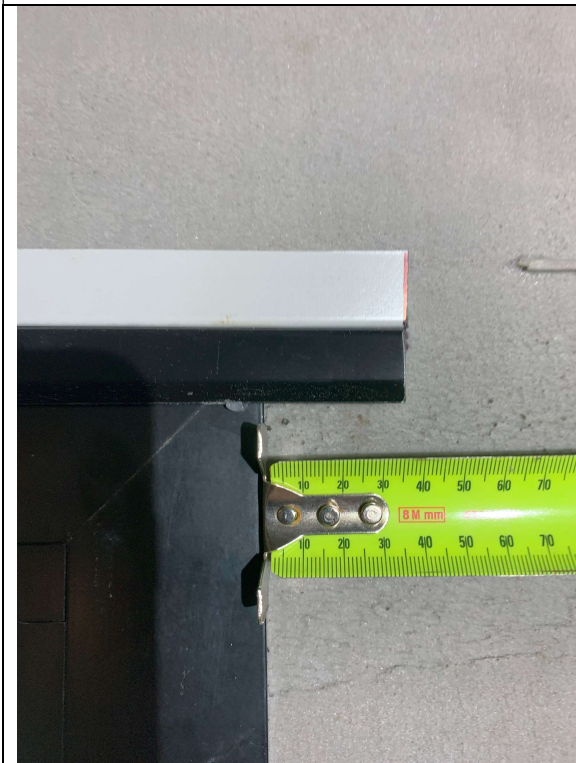
*Figure 4 – Head
flashing overlap to jamb
of only 35mm*

Preliminary testing showed the window fixings to have a minor leak. The window was re-fitted with repair to the rough opening flashing tapes and the inclusion of Bitufoam along the jamb flashing to cladding interface.

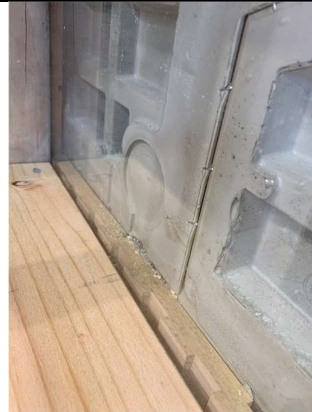
Obs. No:	Test	Observation	Photo
1	Series 1 – Cyclic Water	No water penetration of the Clickbrick panels evident on either sample.

The Clickbrick panels did not allow any water to pass through the panel joints under static and cyclic water penetration testing.

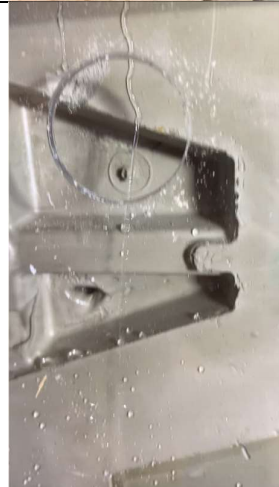
2	Series 3 wetwall test	Water not pooling within the panel cavities. Water generally following a drainage plane along the inner face of the cladding panels, however this was splattering across to the membrane side of the cavity battens.

After the introduction of 6mm diameter holes to create a simulated failure of the panel system, water running down the inside of the panels did travel across the cavity to the peel and stick membrane. The water did not however pool and freely drained.

Booth Test Pressure Pa	Time	Comments
0 Pa	5 min.	<i>5:37</i>
50 pa	15 min.	<i>WATER SPLATTER TO AIR BARRIER</i>
0 Pa	5 min.

BATTEN AREA - FAIL.

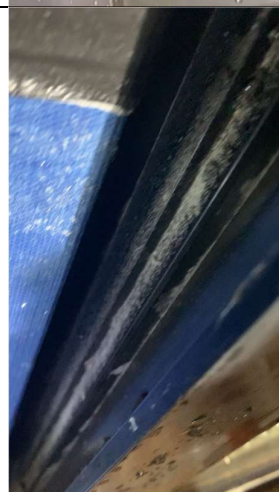
3	Post all tests	Removal of the Clickbrick panels around the window revealed that all of the jamb and head area surfaces were completely dry.

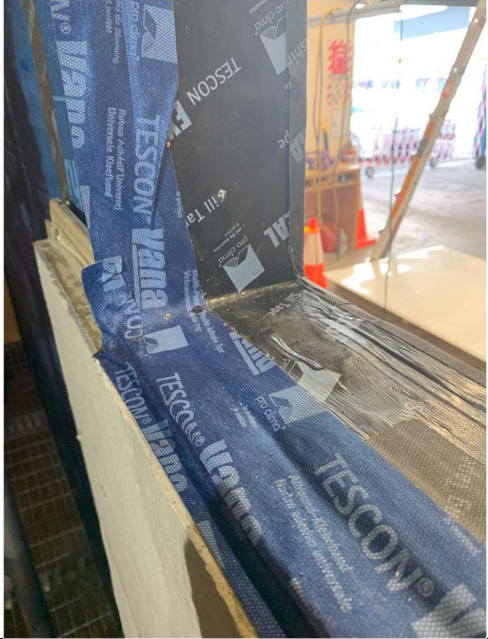
4	Post all tests	As above. Note the window sill flashing tape extending onto the Clickbrick panel.

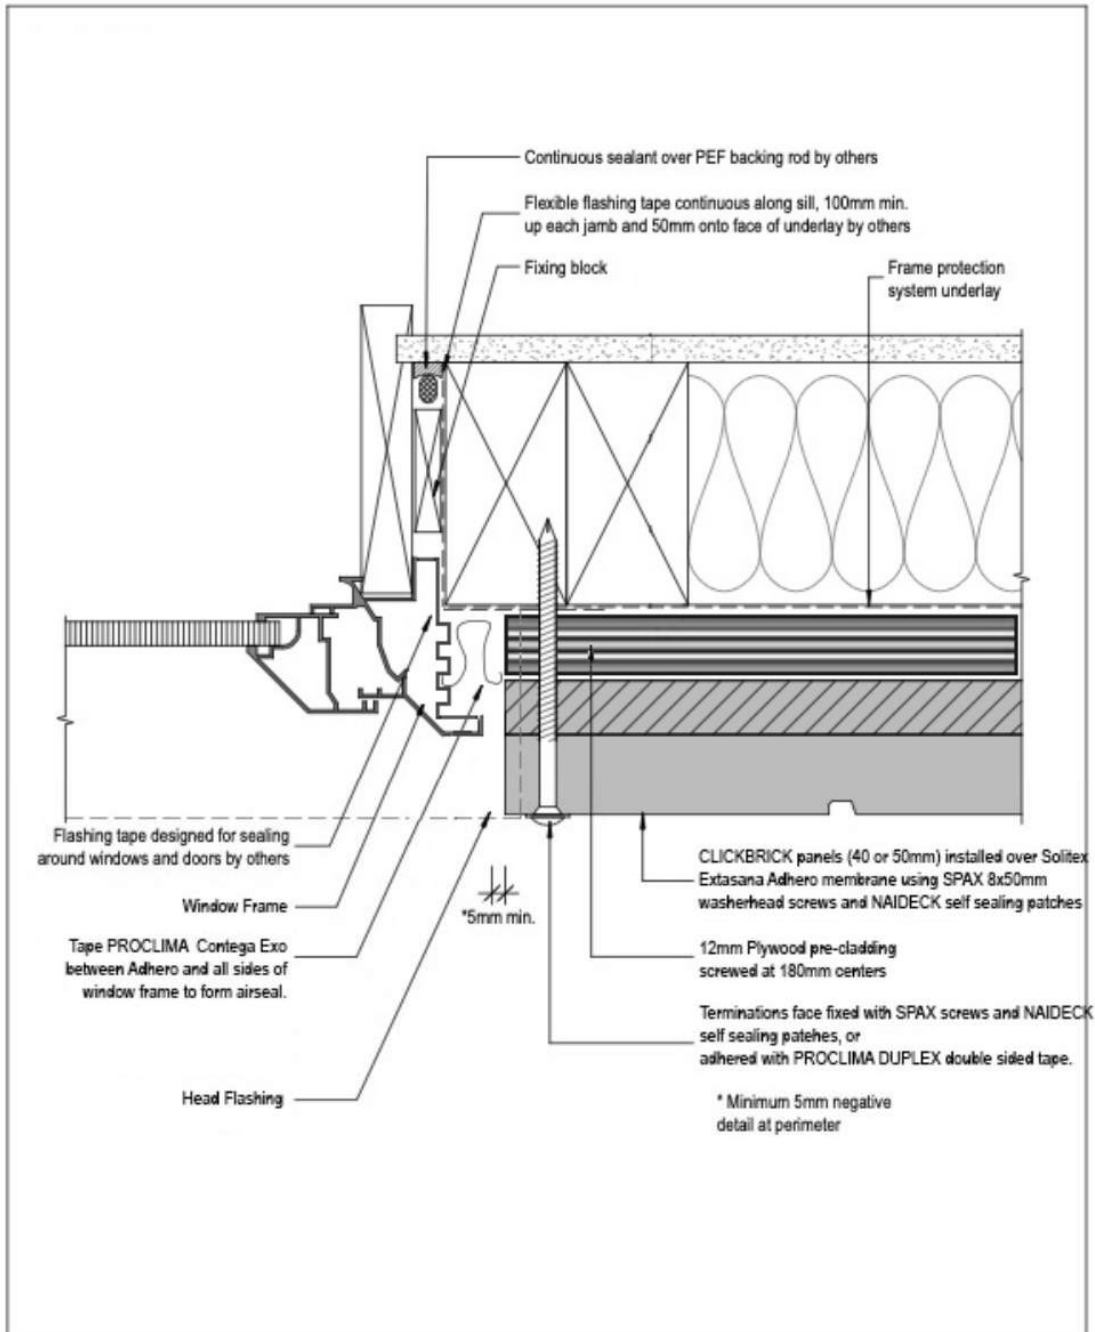
<h2>Modular Panel System</h2>	Window Detail-Jamb-Abutting Panel-Timber Frame	
		Date: Sept 2019 Drawn by: Design Content Checked by: DS	<h1>3.1.1</h1> <p>Scale: 1 : 2</p>

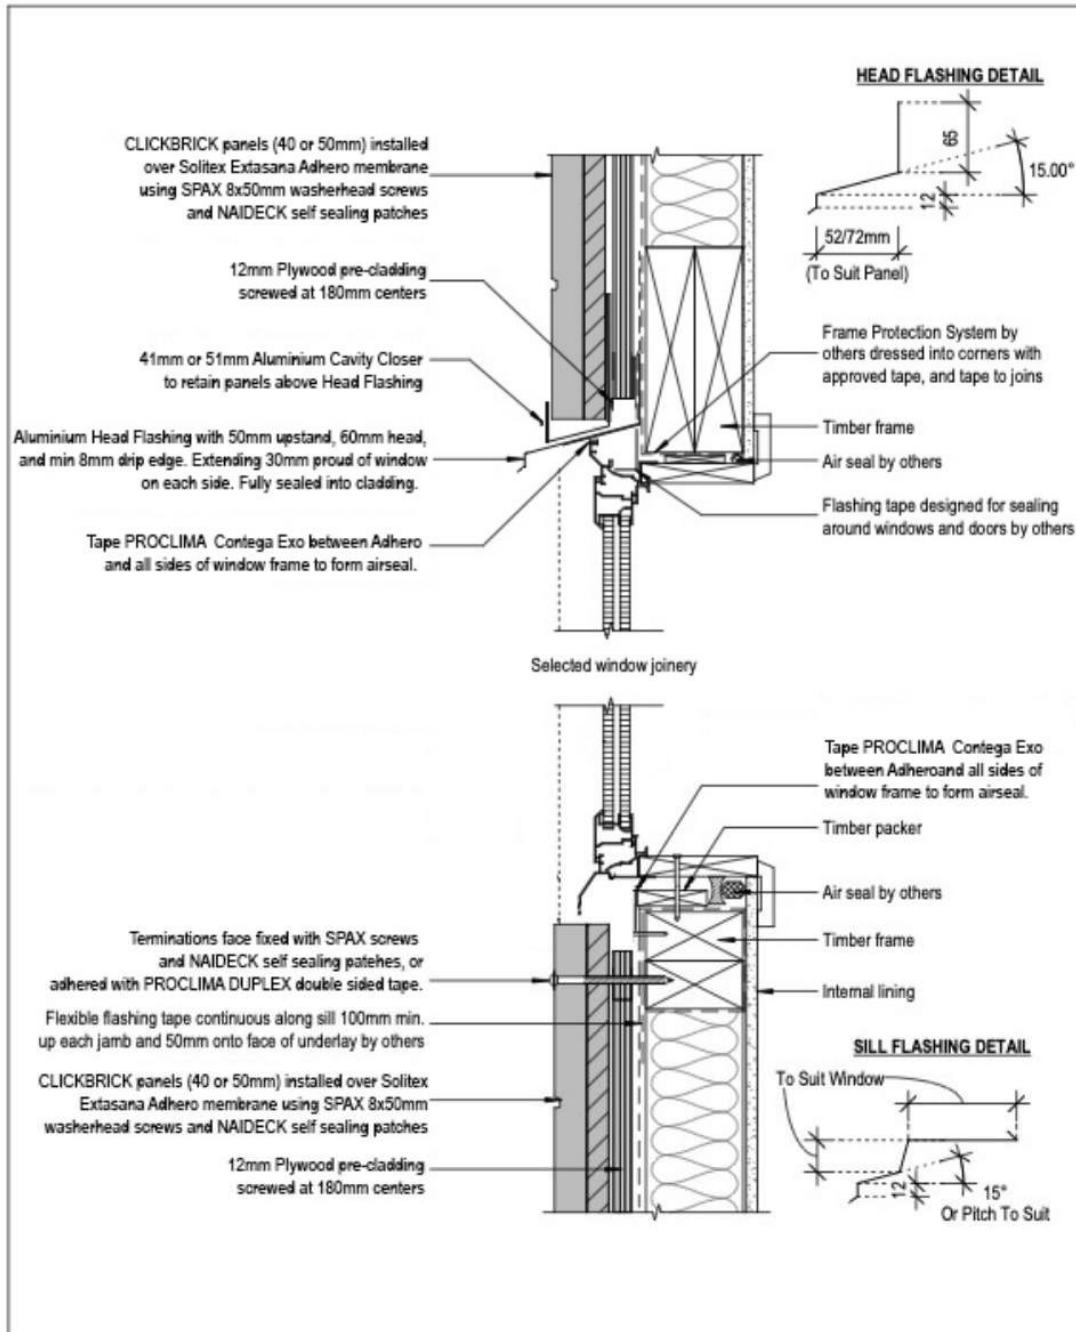
<p>Modular Panel System</p>	<p>Window Detail-Abutting Panel-Timber Frame (No Sill)</p>	
		<p>Date: Sept 2019</p>	<p>3.1.0 A</p>
		<p>Drawn by: Design Content</p>	<p>Scale: 1 : 5</p>
		<p>Checked by: DS</p>
